CMD: 22-M37

Technical briefing

CNSC staff update on elevated hydrogen equivalent concentration discovery events in the pressure tubes of reactors in extended operation

**All nuclear power plant licensees**

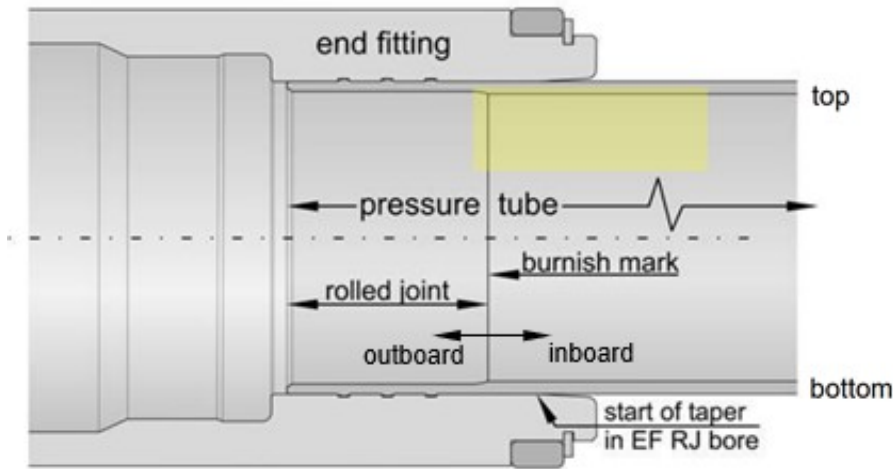
Figure 1: Schematic diagram of a pressure tube at the end fitting

elevated Heq in the Bruce Power pressure tubes near the outlet rolled joint burnish mark (ORJ-BM) -- see **Figure 1** for a schematic diagram of the relevant portion of a pressure tube. The findings were observed in a Bruce Unit 6 pressure tube that was removed for material surveillance during the major component replacement outage (tube B6S13) and in several in-service scrapes obtained from Bruce Unit 3 pressure tubes during a physical inspection.

The Heq values measured in these pressure tubes, which was restricted to a small region near the top of the pressure tubes (as highlighted in yellow in **Figure 1**), exceeded the limit of 120 ppm established for the accepted pressure tube fracture toughness model. In the unlikely event that there is a sufficiently large pressure transient combined with the presence of a flaw in the high Heq area of the pressure tube, the lower fracture toughness could lead to a pressure tube rupture. As such, the findings from the pressure tube examinations raised questions regarding conclusions of the pressure tube fitness for service evaluations performed with the accepted model.

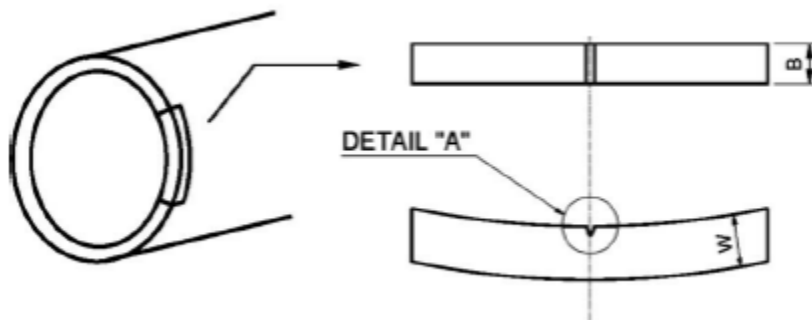
Figure 2: Test specimen showing Vee-notch flaw (Source: Bruce Power)

Early test results showed no changes between  $K_{IH}$  and  $p_c$  for material with Heq of 60 ppm or 240 ppm. These results suggest that the current model could demonstrate that there is no reduction in crack initiation behaviour for pressure tubes with elevated Heq. Additional tests have been completed for a specimen with a specific flaw geometry (See **Figure 2**).

The results from these tests generated about a 19% reduction in the crack initiation threshold for the 240 ppm tests compared to the 60 ppm tests. The current industry theory is that the finding is the result of an interaction between hydrides forming at the flaw tip and larger bulk hydrides present in the 240 ppm material that are not present in

CNSC staff concluded that these results do not indicate an immediate concern for the Heq scrape measurement flaws that have been introduced to the ORJ-BM ROI in Bruce Unit 3 pressure tubes. Bruce Power provided a detailed stress analysis for the scrape flaws and demonstrated that the stresses arising from scrape flaw geometry are well below the stresses that would be required to initiate cracking. The flaw geometry used in the testing generates more significant stresses when compared to scrape mark geometries and even if the 19% reduction in the crack initiation threshold observed in those was applied to the scrape flaws, the stresses would not be high enough to initiate cracking.

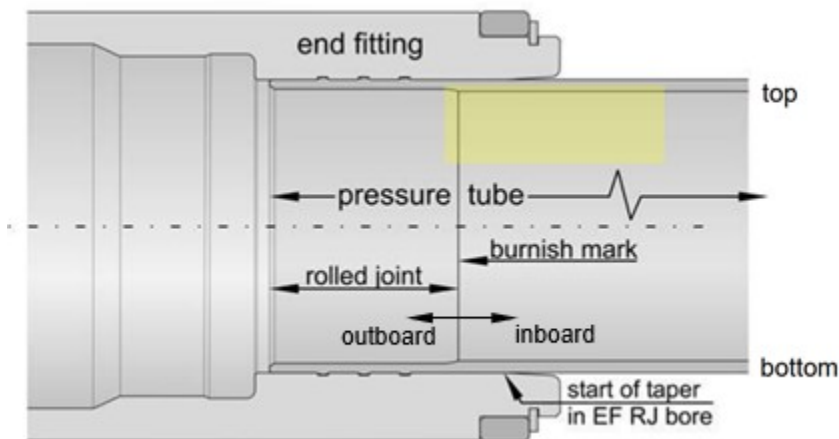
*Appendix Figure 1: pressure tube at end fitting (the yellow shaded region represents the region of where elevated Heq was measured, called "Region of Interest")*

In early July 2021, Bruce Power made a discovery related to pressure tubes in Bruce Nuclear Generating Station (NGS) Units 3 and 6 [A2], [A3]. Namely, the measured Heq near the ORJ-BM of some pressure tubes exceeded the Bruce Power Reactor Operating Licence (PROL 18.02/2028) Condition 15.3 limit of 120 ppm. Bruce Power reported that material surveillance testing of pressure tube B6S13 had an Heq measurement of 211 ppm at the burnish mark (BM) and 212 ppm at the BM plus 10 mm inboard. The Heq value predicted by the model at the BM was 103 ppm. Similar elevated Heq values were later reported from in-service scrape measurements in Bruce Unit 3 pressure tubes. The approximate area of the pressure tube impacted by the measurements from the perspective of pressure tube fitness for service is illustrated in **Appendix Figure 1**.

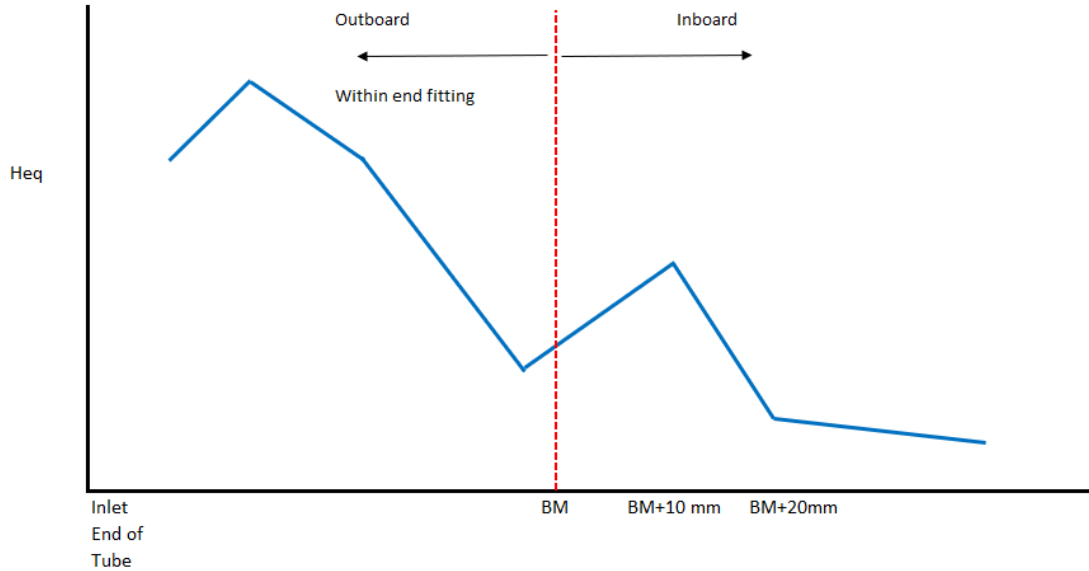
Appendix Figure 2: Diagram of IRJ-BM Heq “blips” (Note: This diagram is not to scale)

The region of elevated Heq in this case was more localized in axial extent than was observed near the outlet rolled joint burnish mark and is referred to as a “blip” because of the appearance of the Heq profiles. **Appendix Figure 2** provides a schematic diagram of a “blip” in the axial direction from the inlet end of a pressure tube.

In addition to the smaller observed extent of the region of the blip at the inlet end of the B6S13 pressure tube compared to the outlet end finding, there are other important factors that should be considered:

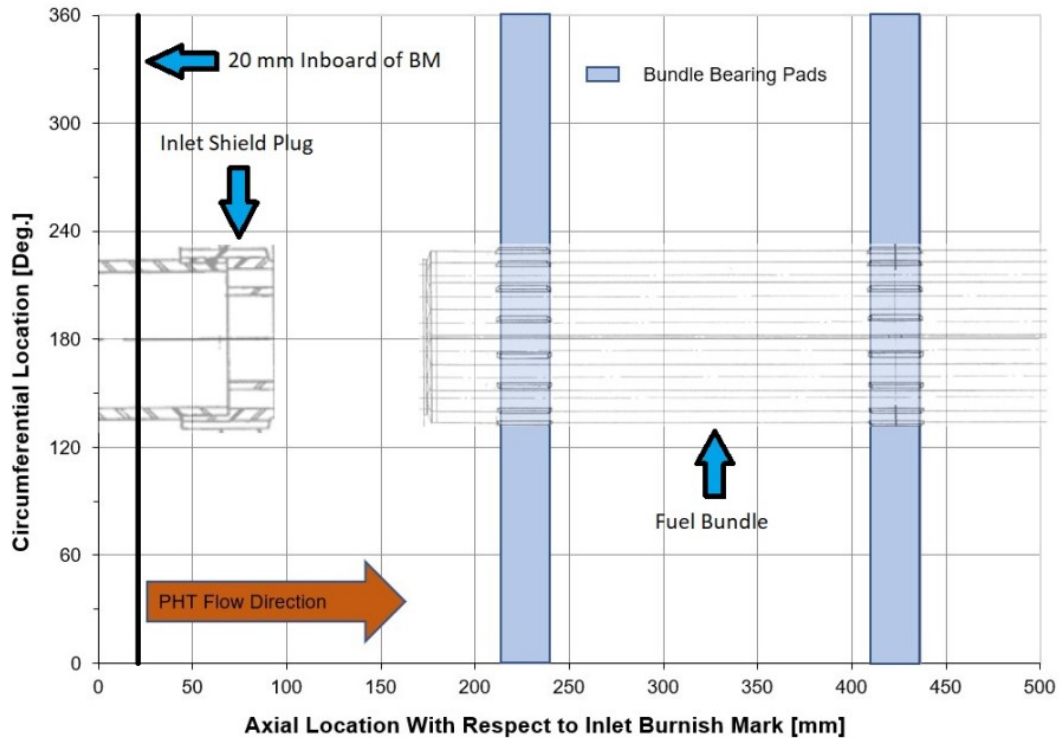
Appendix Figure 3: Inlet end fuel bundle and shield plug configuration in Pickering reactors

For the Pickering reactors, there are no driving mechanisms for the formation of flaws that are at risk for crack initiation since the fuel bundles do not reside at the inlet rolled joint burnish mark during operation and the shield plug extends almost 100 mm past the burnish mark as illustrated in **Appendix Figure 3**. Therefore, for the Pickering pressure tubes in extended operation, fitness for service can be demonstrated in a manner that is consistent with Restart Criteria Option (b) that was used for the outlet rolled joint elevated Heq issue.
